#### IV. RESEARCHING AND DOCUMENTING YOUR HOME.

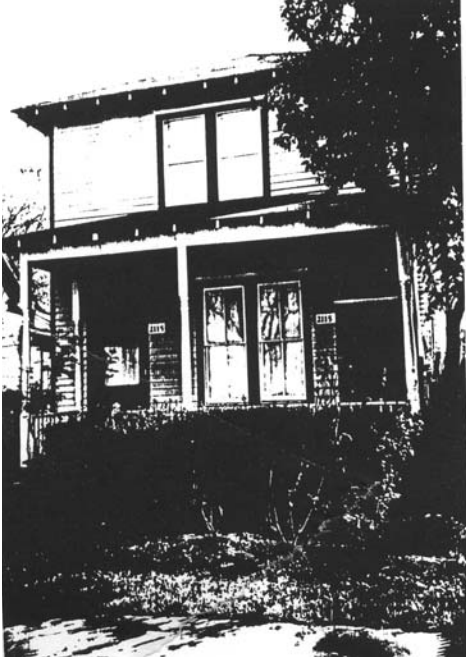
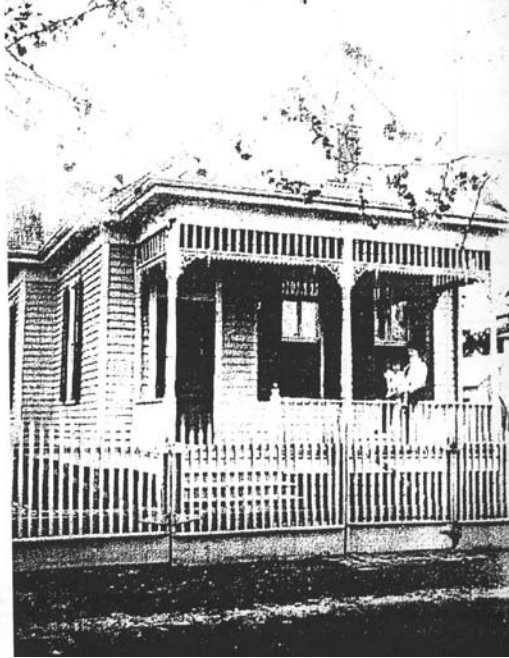
The structure located at 2115 State Street started life as a simple side-hall residence and has evolved into a multi-story rental unit.

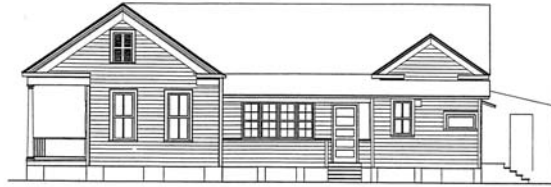
**SIDE ELEVATION (EAST) EXISTING**

*Features of note: Porch columns/supports from two eras are visible: a mid to late Victorian turned post rests against the porch wall and a more recent c. 1910-20 round column at the front. Additions from at least two different periods appear to the right. The aforementioned additions are inappropriately sited and designed and have sustained extensive water and termite damage and should be removed. Non-structural addition is shown at the far right. Concrete steps are visible at the center and far right.*
